Site Analysis American Creosote Works, Inc. Jackson, Tennessee

EPA Region 4
and OERR

Remedial Response and
Site Analysis
American Creosote Works, Inc.
Jackson, Tennessee

by
Judith M. Begley, Imagery Analyst
The Pionetics Corporation
Warrenton, Virginia 22186

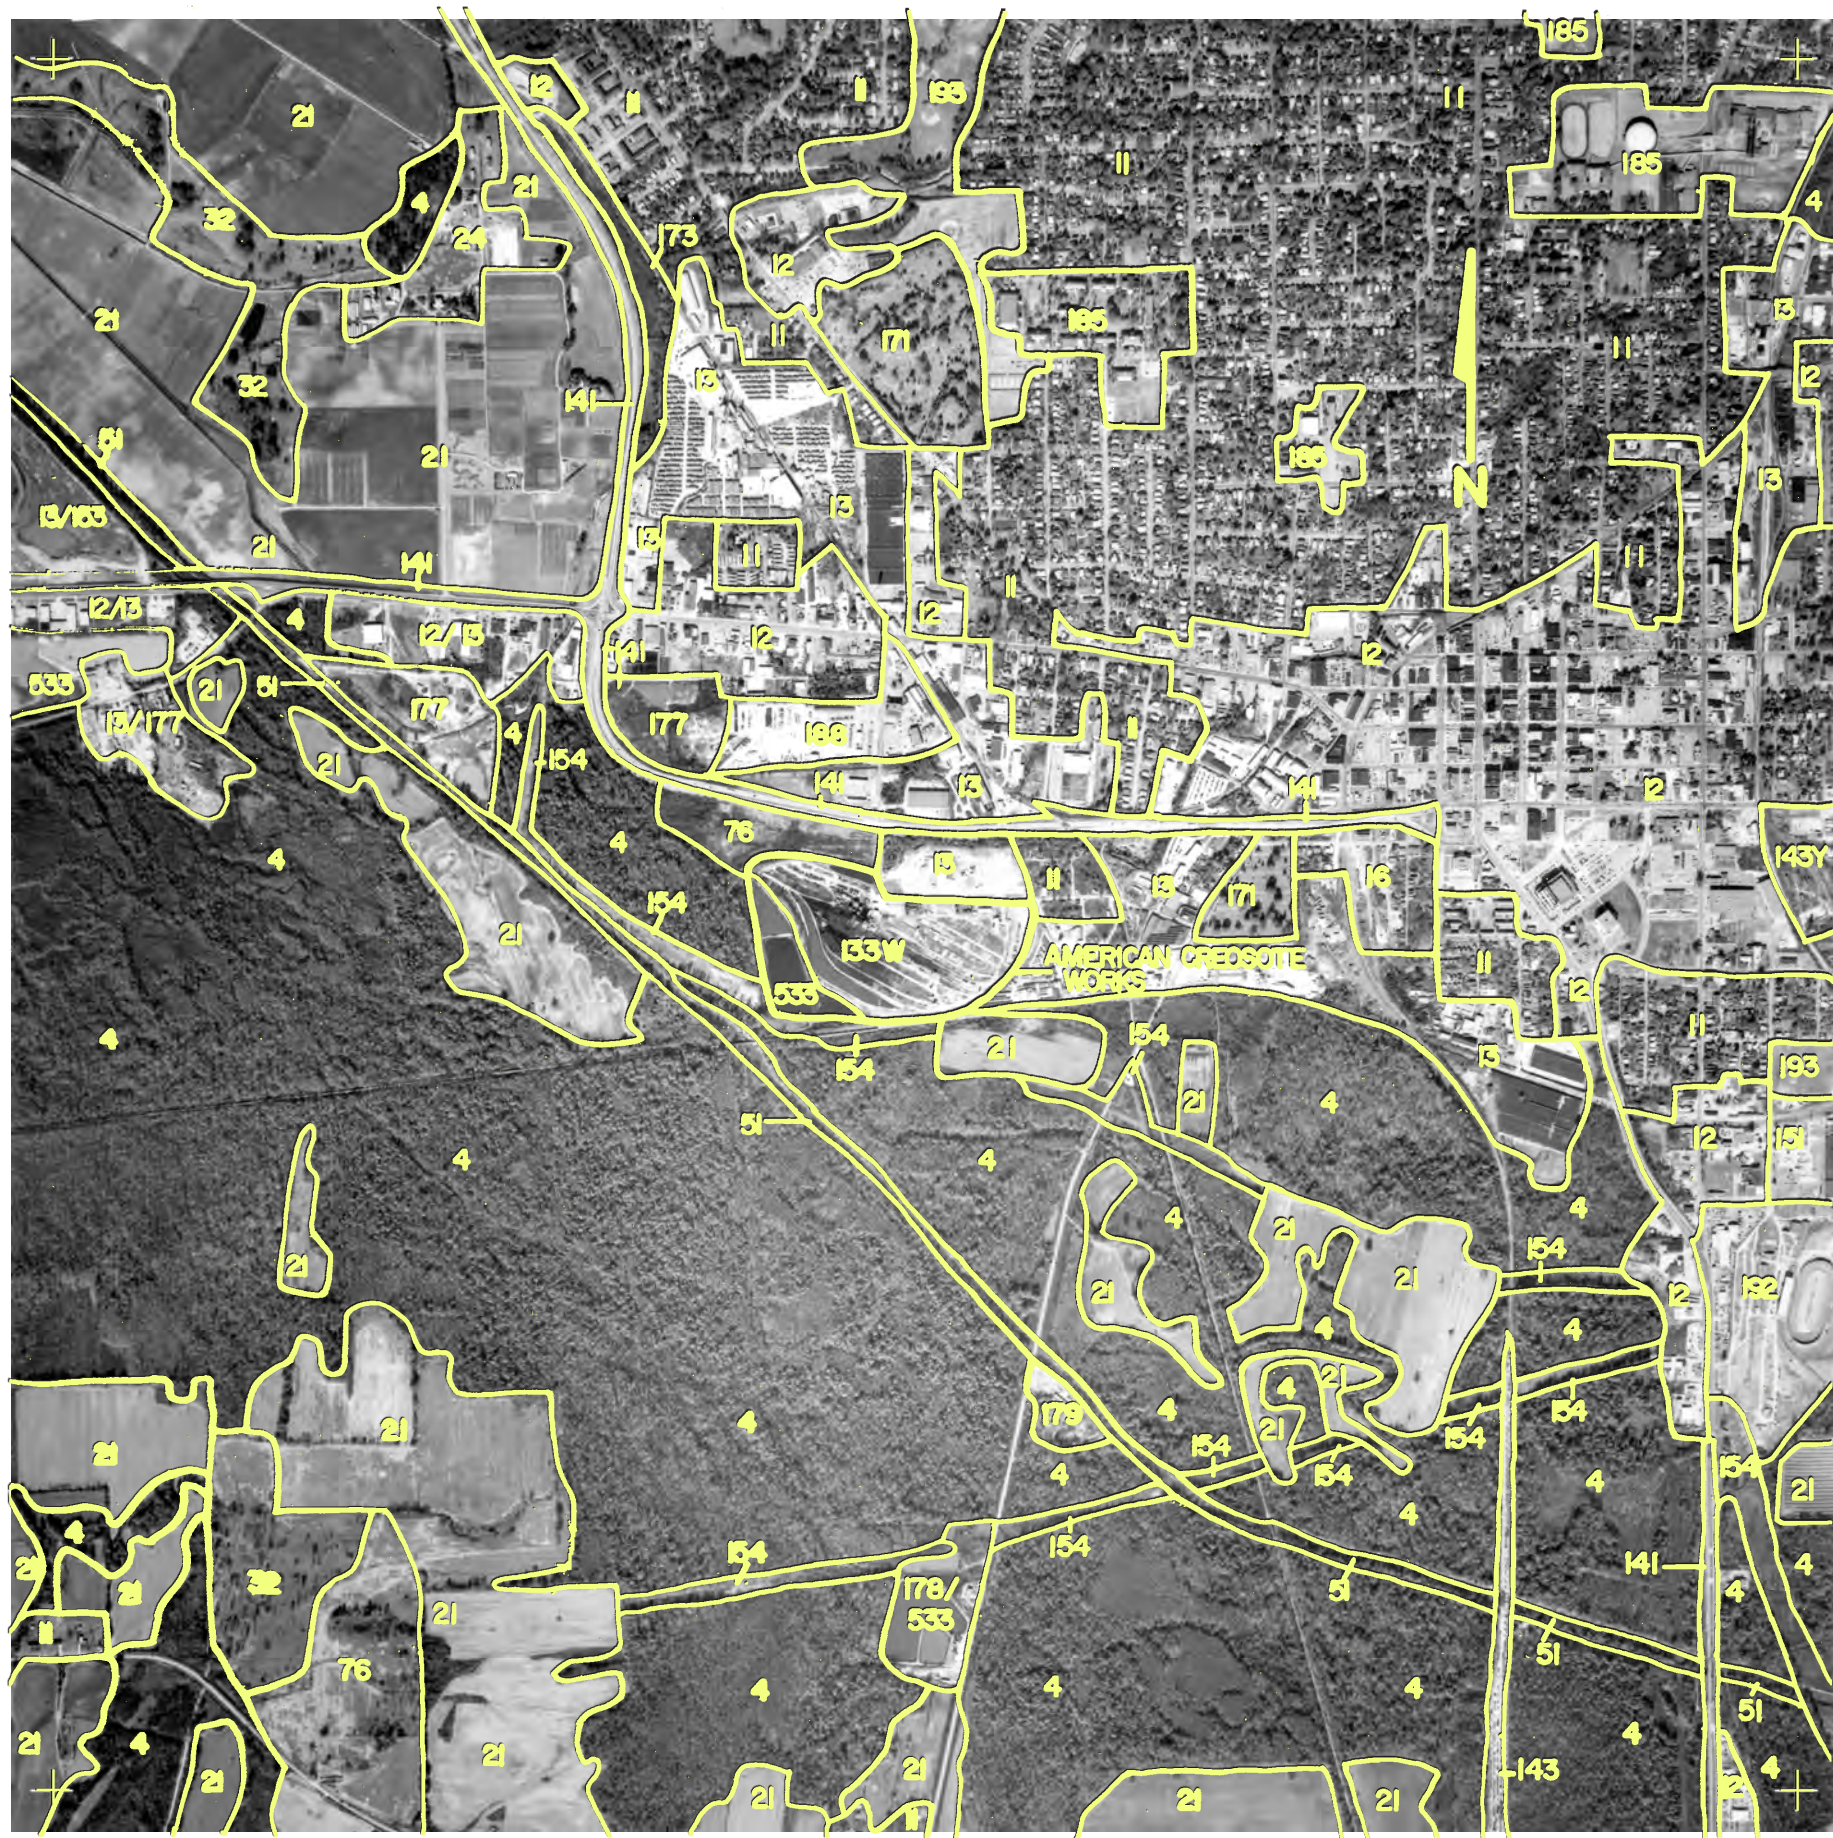
Figure 2. American Creosote Works, land use, November 17, 1979.
Approximate scale 1:17,700.

Figure 2 depicts the various types of land uses and cover within an approximate 2-kilometer (1.2-mile) radius of the American Creosote Works site. The land use classification system used in this report was adapted from a United States Department of Interior publication¹ on land use identification using remote sensor data. Minor modifications to this system were required to provide an accurate representation of land usage in the area.
